RECREATIONAL WATERS // CHLORAMINES

APPLICATION: Chloramines Reduction // **MARKET:** Recreational Water // **LOCATION:** Division 1 University, Ohio, USA

The UV Movement

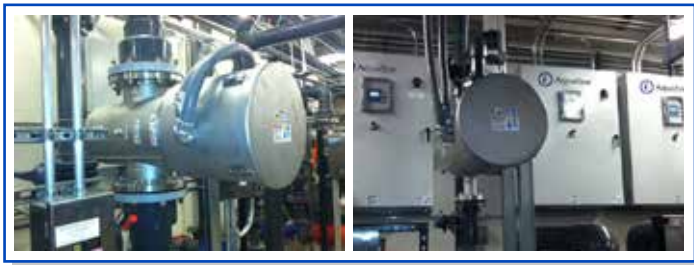
LOCATION	AQUAFINE UNIT TYPE INSTALLED
Competition Pool	MPR-4L12
Dive Pool	MPR-2L12
Dive Spa	MPR-1L12
Leisure Spa	MPR-1L12
Recreational Lap Pool	MPR-1L12
Leisure Pool	MPR-1L12

Figure 1 // Aquafine MPR systems were installed on six pools in the RPAC Aquatic Center.

Aquafine MPR systems were installed on six pools in the Aquatic Center, in accordance to the University's "Swimming Pool Ultraviolet Disinfection Equipment and Installation Specification." Aquafine acted as the General Contractor and supervised the installation and project management. These systems use medium-pressure (MP) lamp technology and are well-suited for flow rates greater than 25 gallons per minute (GPM). By utilizing MP technology, lamp count
